## **KARST SINKHOLES STABILITY ASSESSMENT IN CHERIA AREA, NE ALGERIA**

**AZIZI Y.<sup>1\*</sup>, BOUMEZBEURA A.<sup>2</sup>, MENANI M.R.<sup>3</sup>, BOUCENNA F.<sup>1</sup>**

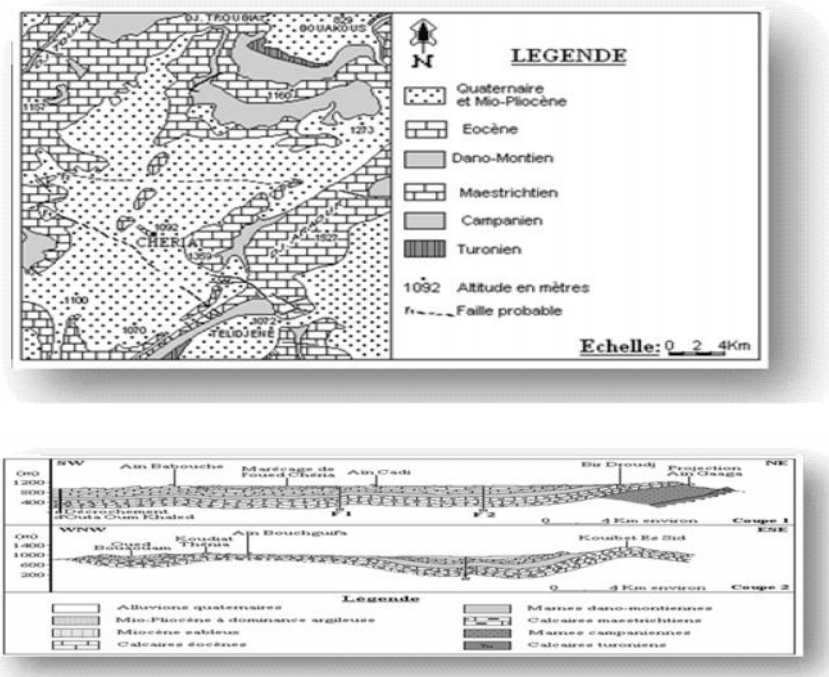
**Figure 2 :** Geological cross section of the studied region

From a hydrogeological point of view, Eocene limestone formation constitutes the most extensive aquifer in Cheria basin. The perennial water availability in the study area is related to the great potential of Eocene limestone aquifer. The marly-limestone bedrock forms the lower boundary of the groundwater

reservoir (Fig. 2). The thickness of the Eocene limestone aquifer increases towards the central part of the basin (Chaffai et al. 2003). The alluvial aquifer is not appreciably used for drinking water, as it used to be, because of its relatively poor quality acquired recently by agriculture, domestic and industrial pollutants. Compared to the Eocene aquifer, this later remains of limited extent and thus limited reserves. The general flow direction for both Eocene and Quaternary aquifers is from the north to the south guided most of the time by the fractures and the morphology (Fig. 3)

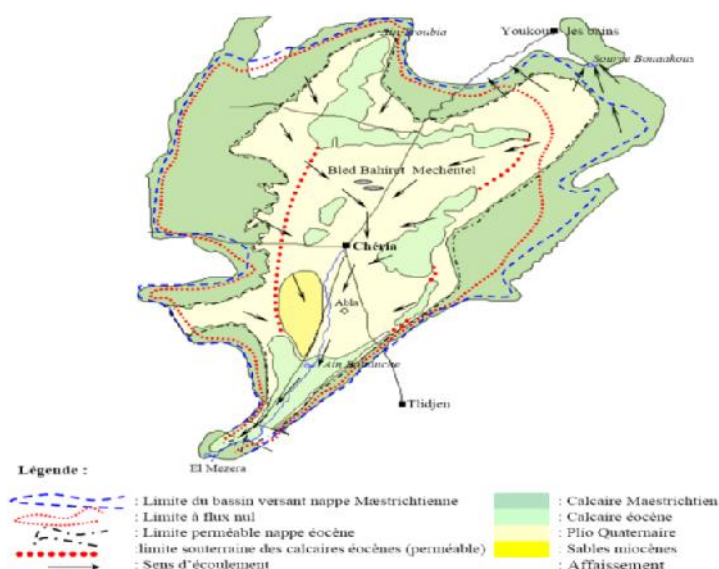
**Figure 3:** boundary condition map for the study area.

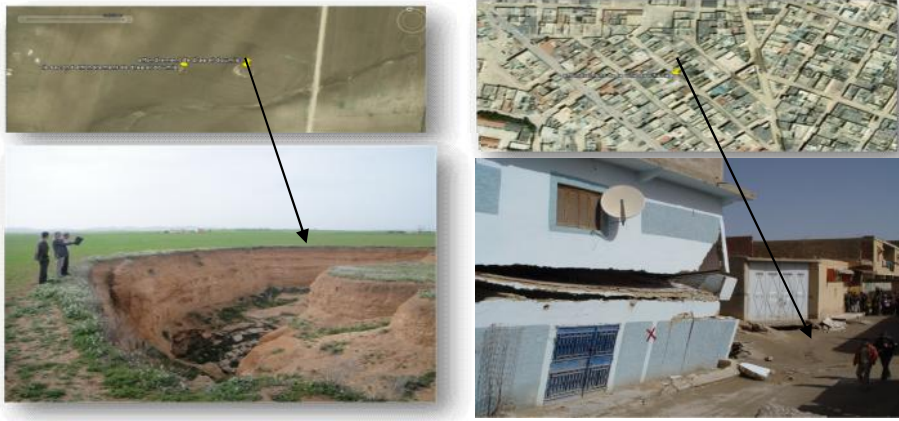
**Figure 4:** boundary condition map for the study area.

Sinkhole collapse is a well-known phenomenon in Cherea area, N E Algeria (Fig. 4). It has been reported that during the last century small diameter sinkholes appear from time to time in Cheria area without making any harm to people or infrastructures. They were not considered as a challenge to security or safety and so they were not of some concern to population or of local

The water level was then very close to the surface, mainly in the southern part of the basin. The wells drilled for underground water extraction show that voids were encountered at a depth between 1 to 50 m. The voids vary in height, between 1 m to several meters throughout the area. In recent years, two large events of cover collapse sinkholes were recorded (Fig. 4).

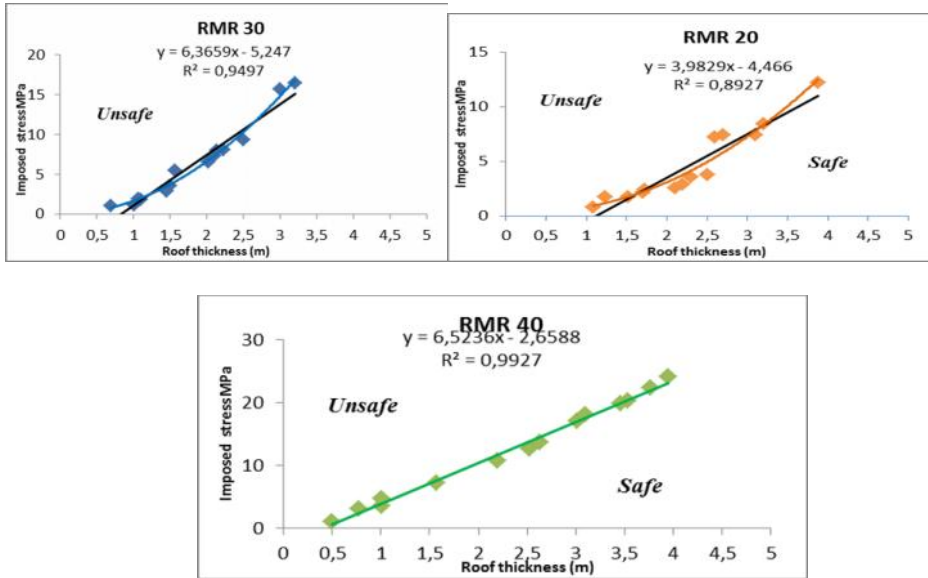
**Figure 5:** Graphs showing the relationship between imposed loading and the critical roof thickness for different values of RMR.

The modeling results show that for a given RMR and a cavity width the resistance to failure increases as the roof thickness increases (Fig. 5). When the roof thickness, the imposed load and the cavity width are kept fixe the resistance to failure increases as the RMR increases. For instance, a 6 m wide cavity with a roof thickness of 2 m, the resistance to failure increases from 4

MPa when RMR equals 20, to 10 MPa when RMR becomes 40 (Fig.5). The results also show that when the imposed load, 1 MPa, and the RMR are kept fix (Fig. 6), the relationship between cavity width and roof thickness, at failure, is of a linear form. For an RMR of 40, the ratio of roof thickness to cavity width is about 0.30. This ration is of almost 0.40 for an RMR of 30 and around 0.75 for RMR = 20 (Fig. 7). It can be easily seen that in the case of Cheria Eocene limestone where RMR is 40, an underground cavity can be considered stable if the ratio of the roof thickness to the cavity width is above 0.30 under an imposed load of 1 MPa (10 tones over an area of 1 m<sup>2</sup>).

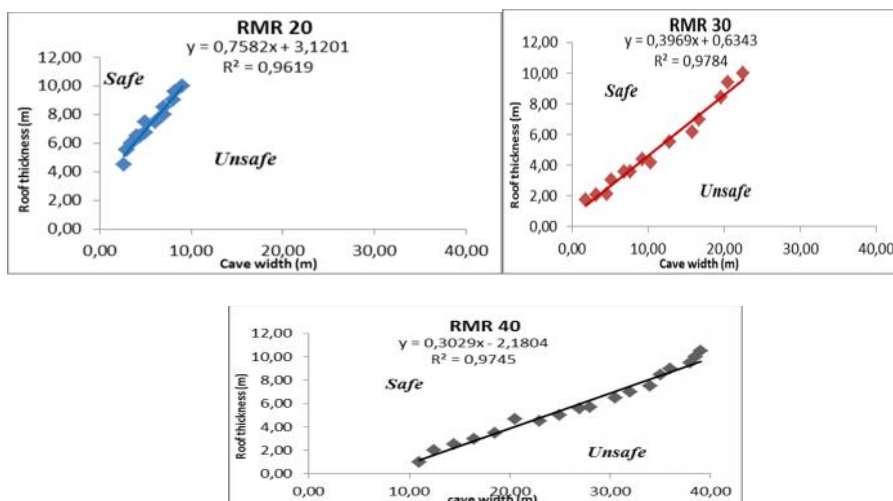
**Figure 6 :** Graphs showing the relationship between roof thickness and width of the cavity for different values of RMR.

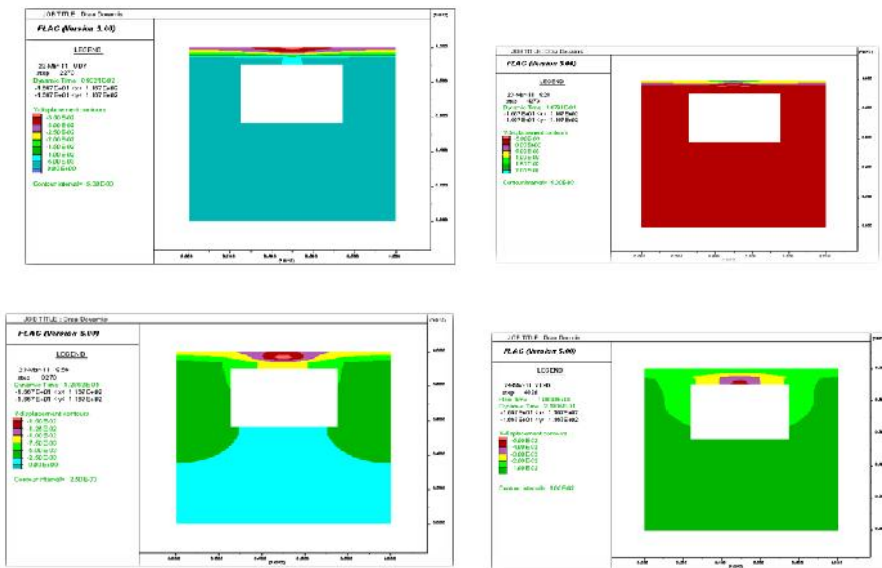
**Figure 7:** Figures showing the influence of ground water fluctuation on the stability of an underground cavity.

For a cavity with varying width and an RMR of 20 the roof displays more resistance to failure as it thickens. Fig. 8 shows that as the cavity width increases roof thickness at the onset of failure, also increases in a linear fashion. The same relationship is applicable for all the RMR values covered by this study. It has been reported that ground water fluctuation causes sinkhole to form in karst environment. The principal mechanism of water effect lies in the lake of buoyancy as water table drops. The pressure caused by moving water, towards the cavity as a result of drawdown or rainfall also contributes significantly to failure. The effect of ground water fluctuation is modeled in this study; the results show that when the piezometric head decreases rapidly from a level above the cavity roof to another below it, failure occurs (Fig. 7).
